**Site 024 Track 1 Decision Documentation**  
**Package, OU 10-08**

**Site Description: Homestead Site Northwest of Specific Manufacturing Capability  
(SMC)/Test Area North (TAN)**

**Site ID: 024**

**Operable Unit: 10-08**

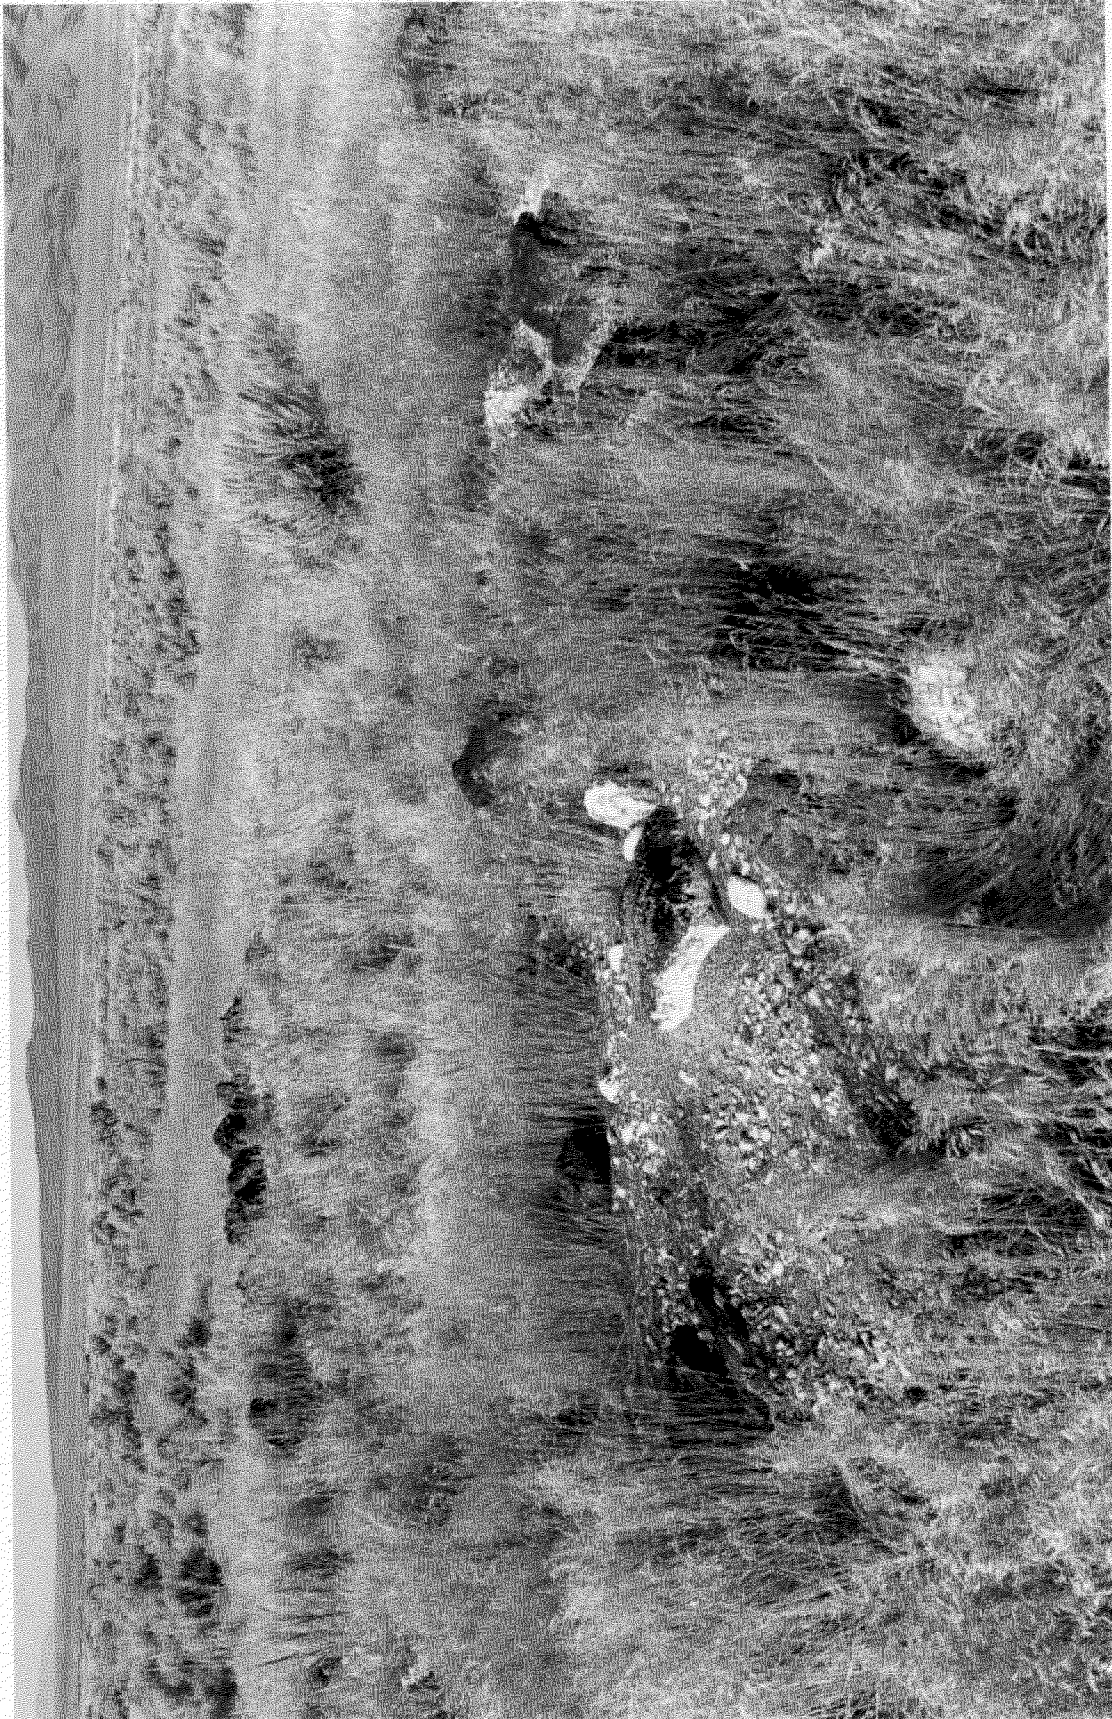
Site: 024, Homestead Site Northwest of SMC  
(PN99-0456-2-21)

Site 024 is recorded as an old pioneer homestead containing remnants of a lava rock foundation, empty rusted cans, wood stoves, weathered wood, wire, broken glass and equipment parts. INEEL Cultural Resource personnel determined that the site is more than fifty years old, and that the artifacts found at the site are domestic in nature, and predate INEEL operations. The site is located between Highway 22 and the Birch Creek drainage gravel pit; 9 miles from the Highway 22/Highway 33 intersection. The site is in the northern section of the INEEL in close proximity to the Birch Creek Playas. Test Area North (TAN) is the closest facility located approximately 6 miles southeast of the site. The surface debris encompasses an area of approximately 150 ft by 150 ft.
